SUPERFUND THIRD FIVE-YEAR REVIEW REPORT**for****A.L. Taylor (Valley of Drums)****Operable Unit 01****Brooks, Bullitt County, Kentucky****PREPARED BY:****US Army Corps of Engineers, Louisville District****for****US Environmental Protection Agency, Region 4
Atlanta, Georgia****February 2003**

SUPERFUND THIRD FIVE-YEAR REVIEW REPORT

A. L. Taylor (Valley of Drums)

Brooks, Bullitt County, Kentucky

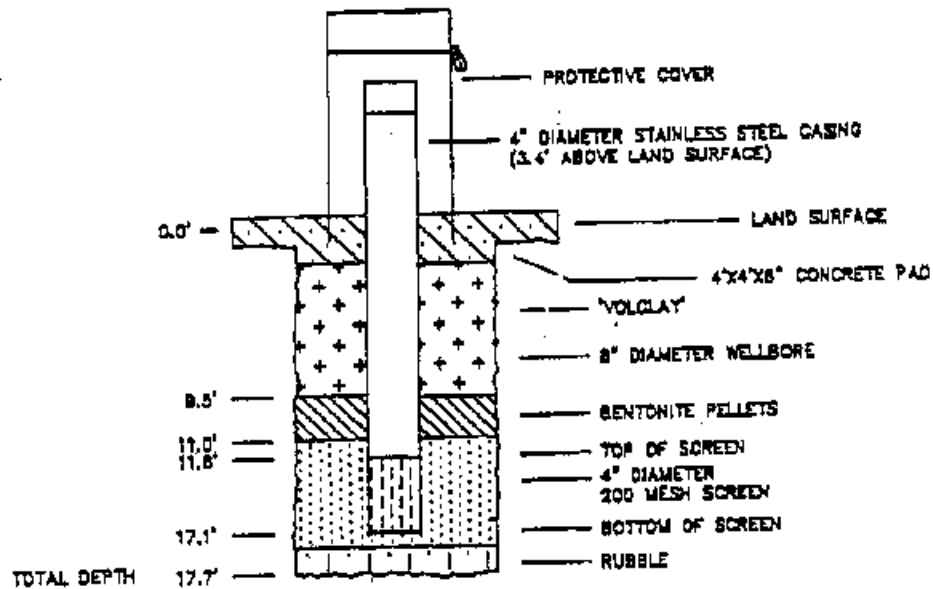
Figure 5
ALT-03 Well Log

1. Well ALT-03 is a critical down-gradient sampling point known to have become fouled. Examination of the well section (Figure 5) indicates that the top of the well sand pack is less than 6-inches above the top of the well screen. For standard construction of wells it is preferred to have at least 2 feet of sand pack above the well screen to prevent the bentonite seal from impacting the screen. Based on the depth of the well, there is
